Building of the Titanic:

The R.M.S Titanic

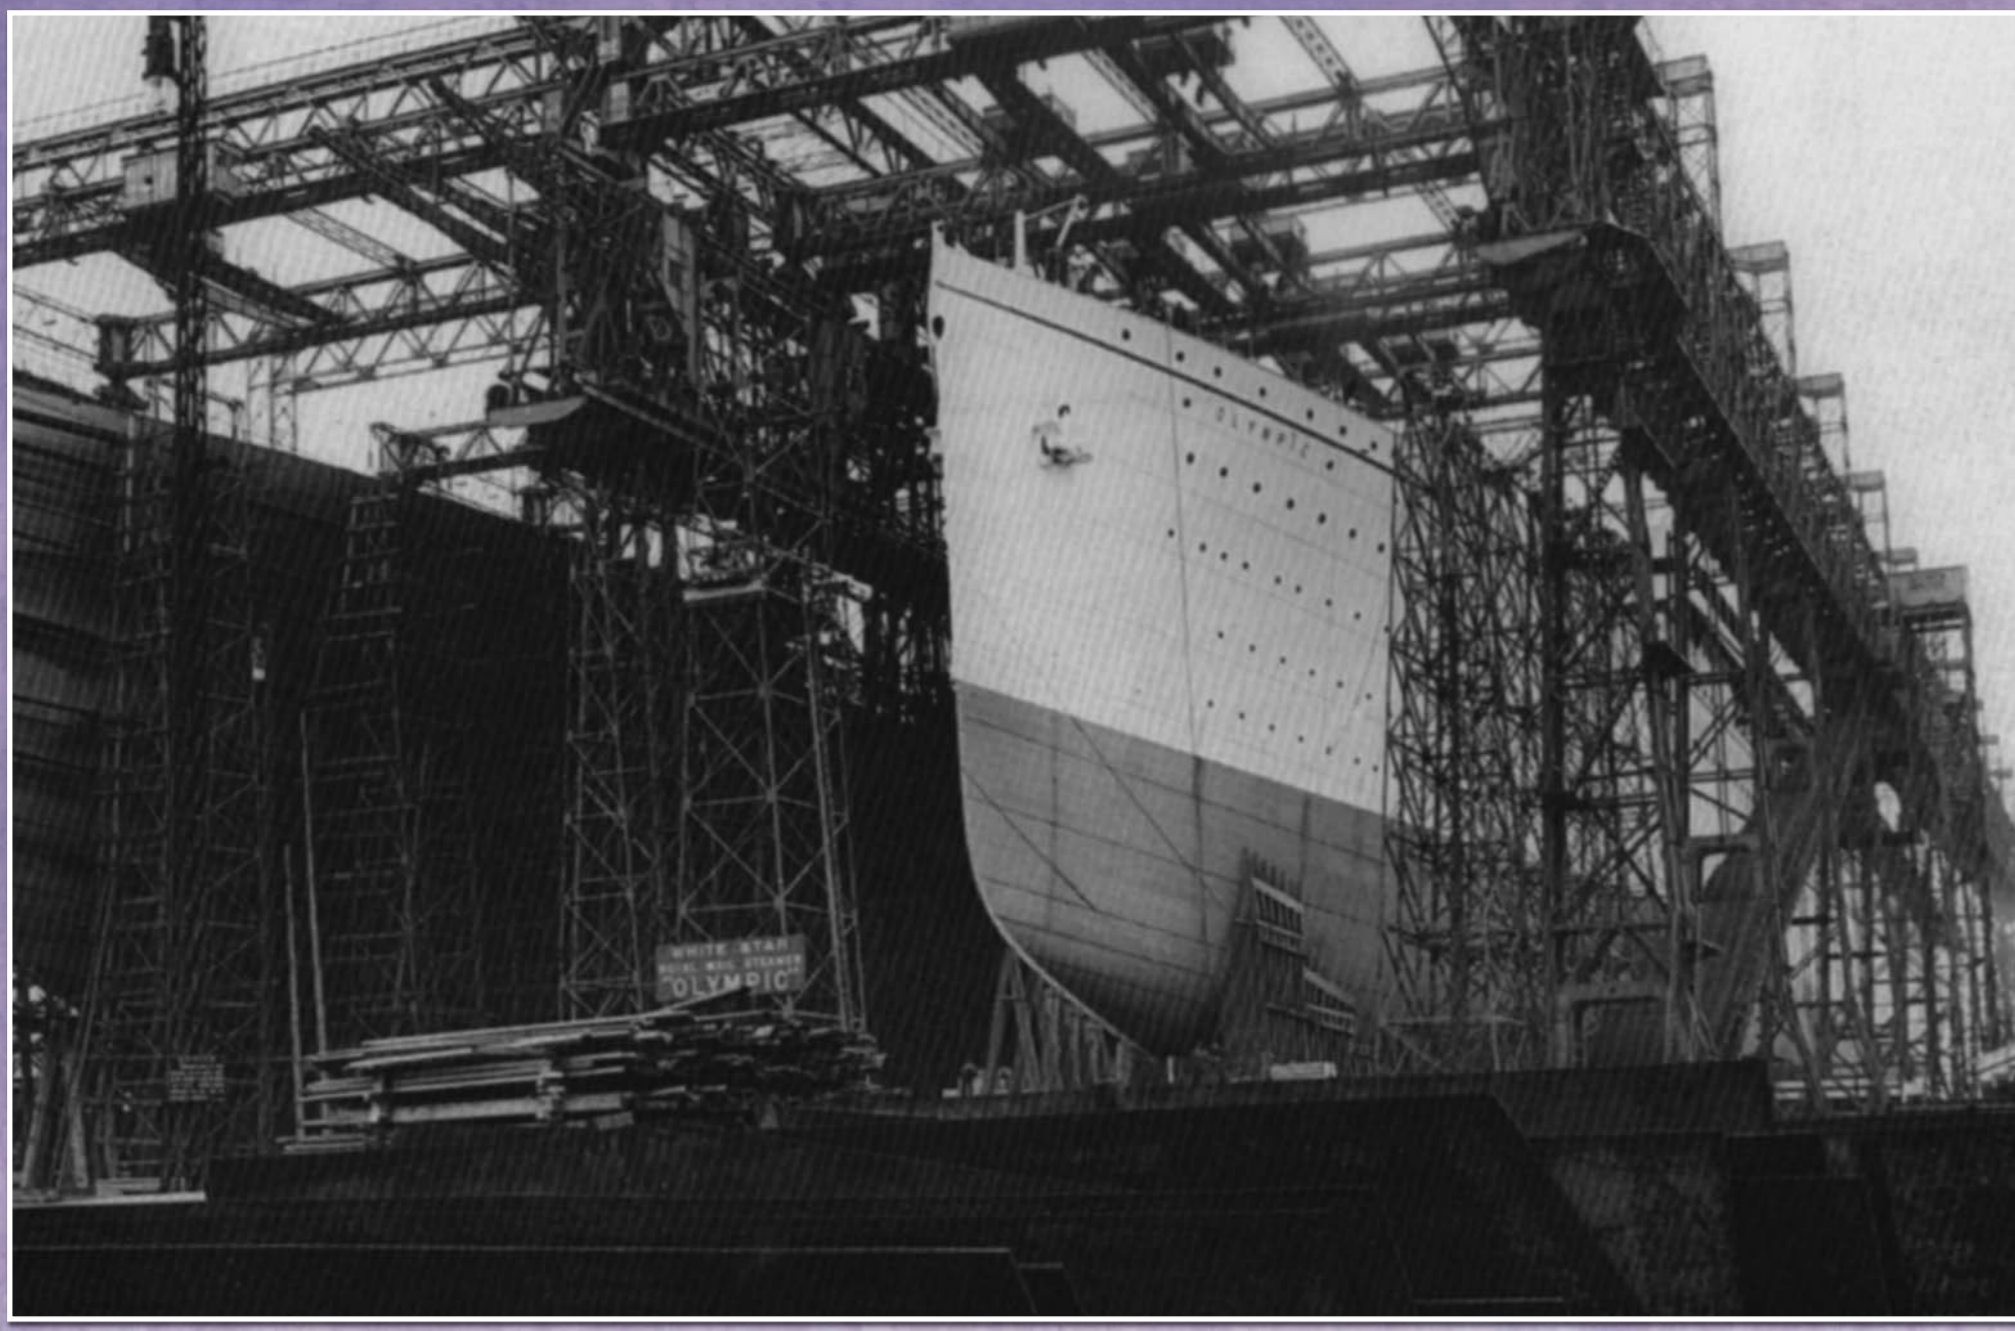
- Titanic was 269m (882ft 9in) in length. The height from her keel plate to the top of the funnels was 53 metres. Her masts were used as flag poles and supports for the Marconi radio receiver. The crow's nest was located on the foremast.

- Titanic and her sister ship, the Olympic, had a gross cargo capacity of 46,329 imperial tonnes.
- She was constructed on a steel frame, clad in a skin of steel plates. More than 3 million metal rivets were used to fasten the ship together.

- The ship was powered by two huge steam engines, powered by 29 boilers, containing 159 coal furnaces, driving the three bronze propellers. Over 660 metric tonnes of coal a day was consumed to produce 46,000 horsepower, delivering a speed of 23 knots or 43kmph.

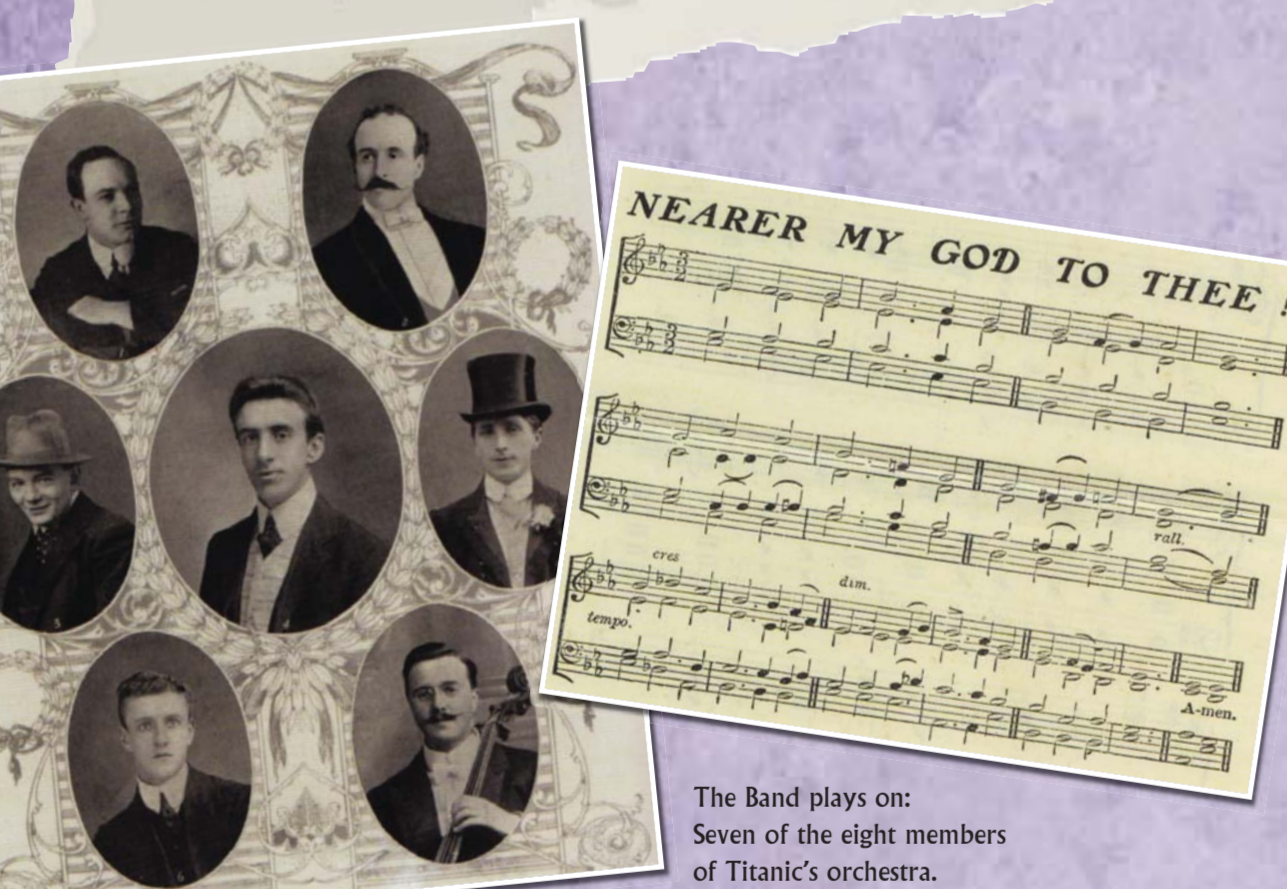
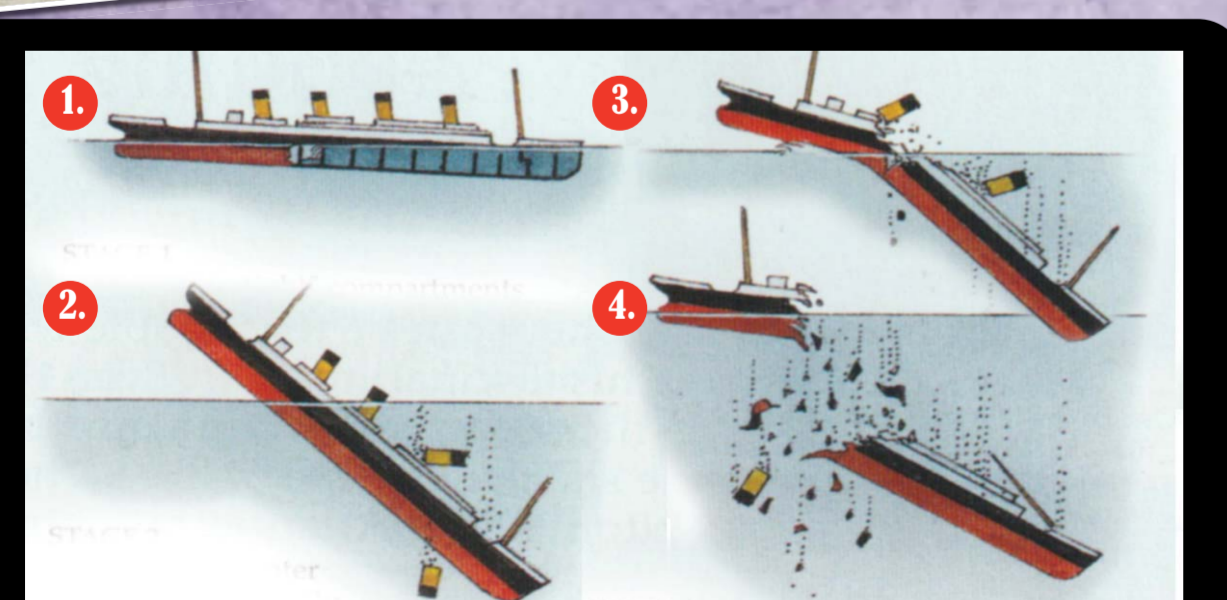
How the Titanic sank:

- Six of the watertight compartments were punctured by the iceberg and took on water. The flooded compartments pulled the bow (front) downwards, causing the water to spill over the bulkheads, flooding more compartments.
- As the bow sank, the stern (rear) rose. The falling debris and collapsing funnels killed many people on the boat deck, including John Jacob Astor IV.
- The keel then broke between the third and fourth funnels and the bow sank. The stern actually floated for a short time, before joining the rest of the ship on the bottom of the Atlantic.

Watertight Compartments – Although Titanic had 16 watertight compartments, the height of the bulkheads separating them was only 3 metres above the waterline. When one compartment flooded, the water simply flowed over the top, flooding the rear sections.

Manoeuvring – It has been speculated that if Titanic had collided with the iceberg bow-first, she may have remained afloat as fewer of the watertight compartments would have been breached. However, other severe damage and fatalities would most certainly have occurred.
